Diaphragm Seal Refurbishment Program

Giving pressure instruments a second life

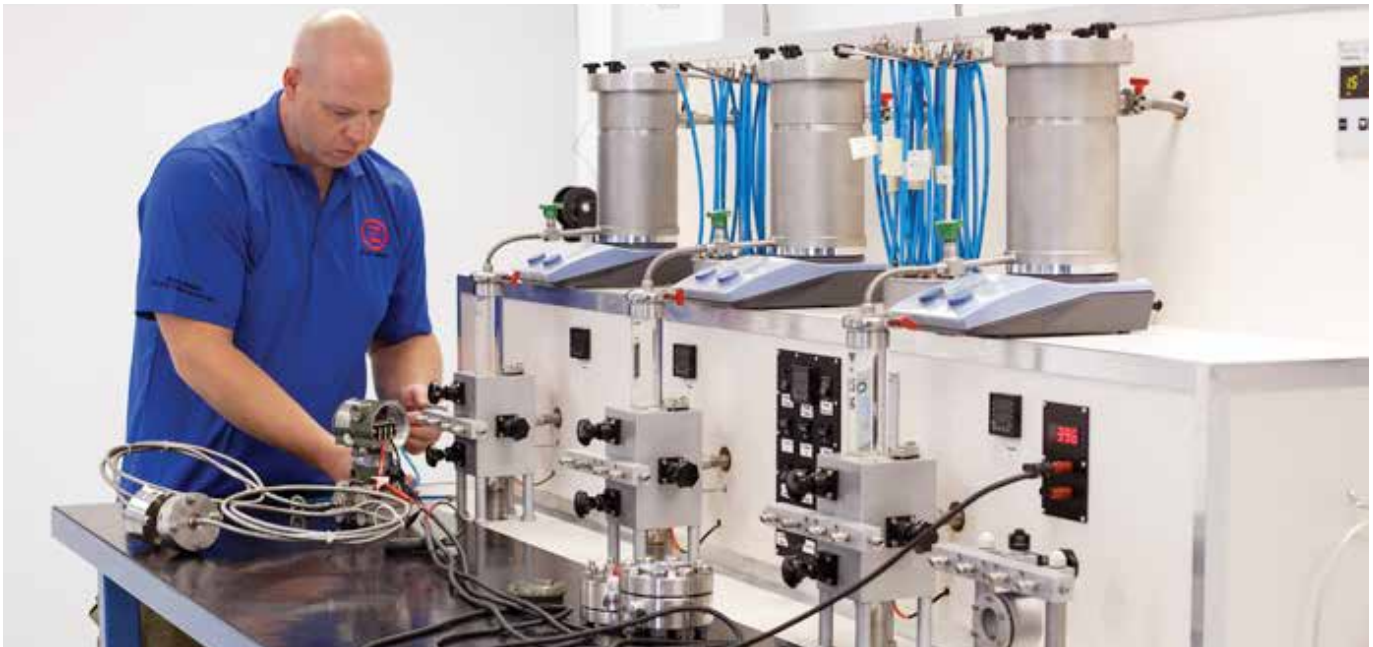
A pressure instrument with Diaphragm Seals is filled under high vacuum at a temperature of +/- 20 °C. When the instrument with Diaphragm Seals is being used at an operating temperature different to this, a measurement error will occur. When the process and/or ambient temperature increase, the filling fluid will expand resulting in a pressure build up, that will be measured by the pressure retainer on top of the actual process pressure. On request, Bliss Americas can determine the expected additional measurement error of an application, so it can be compensated in the system. It is also possible to get a reliable measurement, where the pressure instrument will be set at a given operating process temperature.
